HOW TO REPLACE DRUM (IMAGING UNIT) CHIP FOR XEROX PRINTER

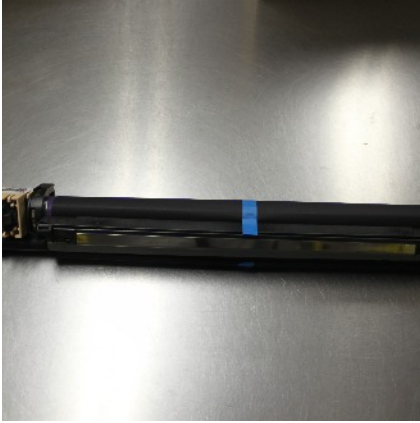
1. take the imaging unit out of the printer, using paper town or soft cloth to cover the imaging unit, this is very important you don't want the drum part get scratch and to exposed to the light more than 5 minutes. it will decrease the quality of print if the imaging unit exposed to the light for long time.

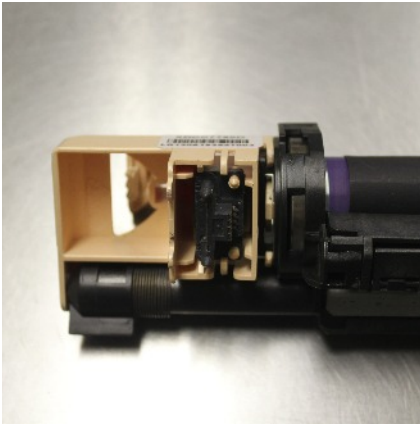
2. locale the chip,

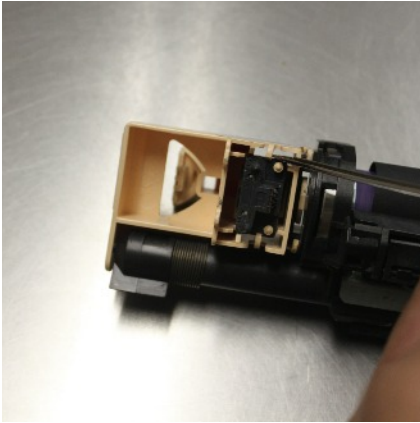
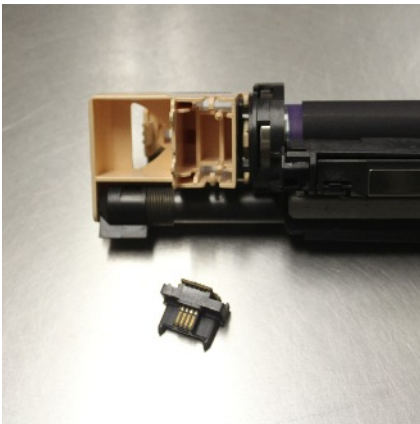
3. take the chip out and replace it with the new chip
